## CREATING PRINCIPLES OF CONSTRUCTING AND PRESERVING THE MONUMENTS OF “DESHAN KALA”

This article provides information about the brick thatched wall which is located in the centre of Khiva City and contains five neighborhoods. The wall was built in 1842 and has been finished within 36 days. This Ichan Kala wall amazes and attracts millions of foreign and local visitors and proves that construction and architecture were well developed in the ancient Khorezm.

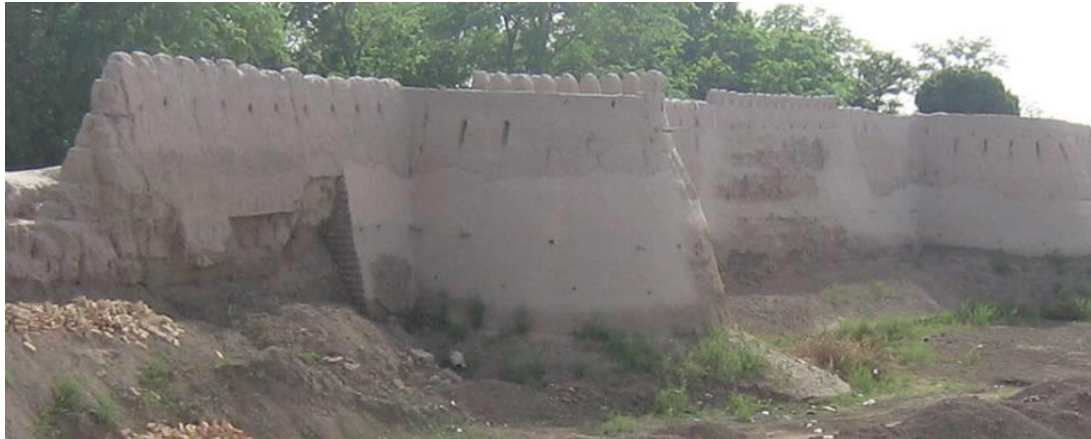
**1-picture. South-western part of “Deshan Kala” walls (taken by E. Salayev. 2022y)**

In this regard, the Deshan Kala architectural monument has come to the level of disappearance as a result of man-made negative effects related to natural and human activities over the centuries (see Fig. 1), but when our scientists researched the existing part by taking a sample, the strength of the wall is sufficient according to regulatory documents. It is noteworthy that it was determined.<sup>1</sup>

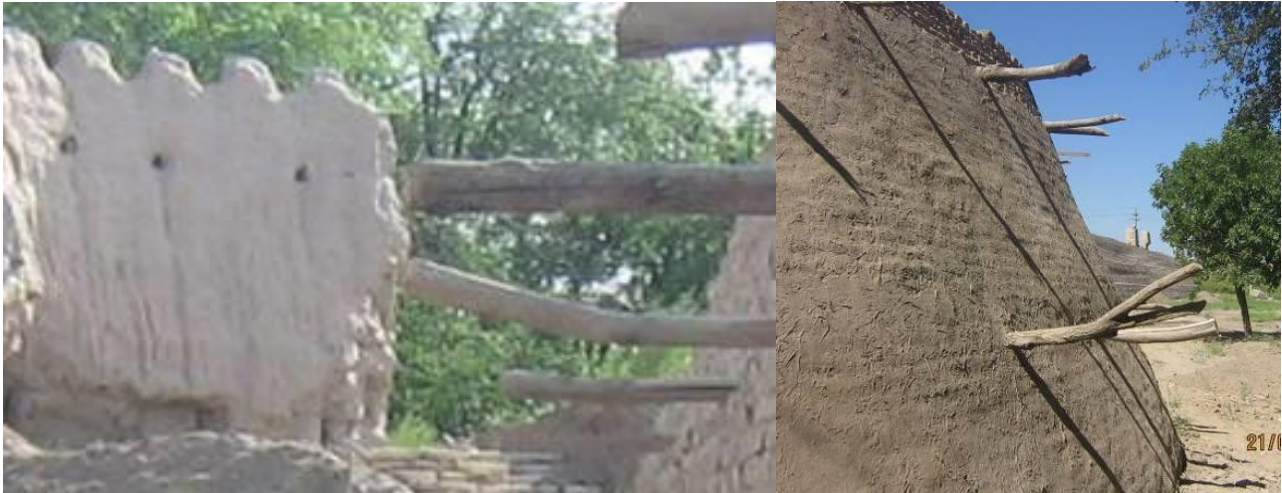
**Figure 3. The usage of the wood logs in the heritage of Deshan Kala wall.  
(Taken by Salayev Ergash in 2013)**

Wood logs were also one of the main construction materials in construction, builders have placed them inside the wall during the construction.

Those logs have been planned to keep the walls resistant to earthquakes and to absorb any moisture and then evaporate, and builders also used the logs as scaffoldings. (check figure 3)

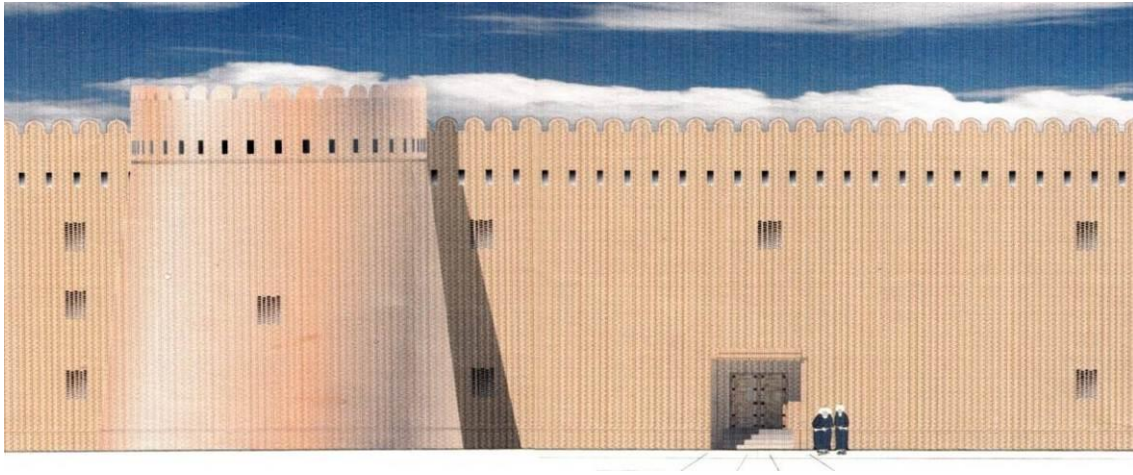
**Figure 4. Planning to reconstruct the walls of “Deshan Kala” (layout)**

The research work carried out by the scientists of Khorezm Ma'mun Academy on preserving the wall of Deshan Castle is commendable. They are giving scientific recommendations to the officials for the repair work of Deshan Castle by analyzing the structural features of the castle, the materials used in its construction and the construction methods<sup>1</sup>. Currently, some parts of the walls have been restored, and some parts are still in the restoration process. Also, projects are being prepared for the complete restoration of the missing parts of the fortress wall (check figure 4).
